California Forestry Report No. 7

February 2023

## Mitigating Potential Sediment Delivery from Post-Fire Salvage Logging

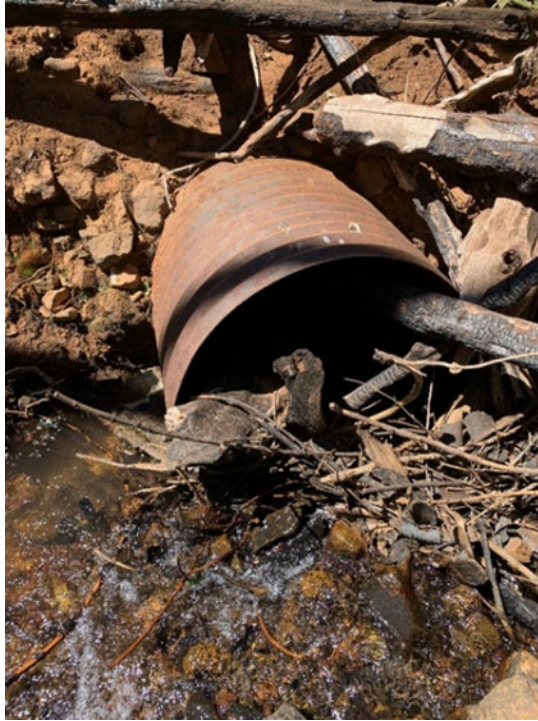
**Figure 4.** A culvert partially blocked by burned wood and debris in the 2020 North Complex Fire in Butte County, California. In this picture, the road is acting as a partial barrier and a sink for runoff, sediment, and debris.

- Roads can be barriers to flowpaths. An example of this may be an elevated road prism on gentle terrain, where the road acts as an embankment that blocks a potential flowpath. Drainage structures (e.g., culverts) at watercourse crossings can often become barriers when excess debris and sediment plugs the structure (**Figure 4**).

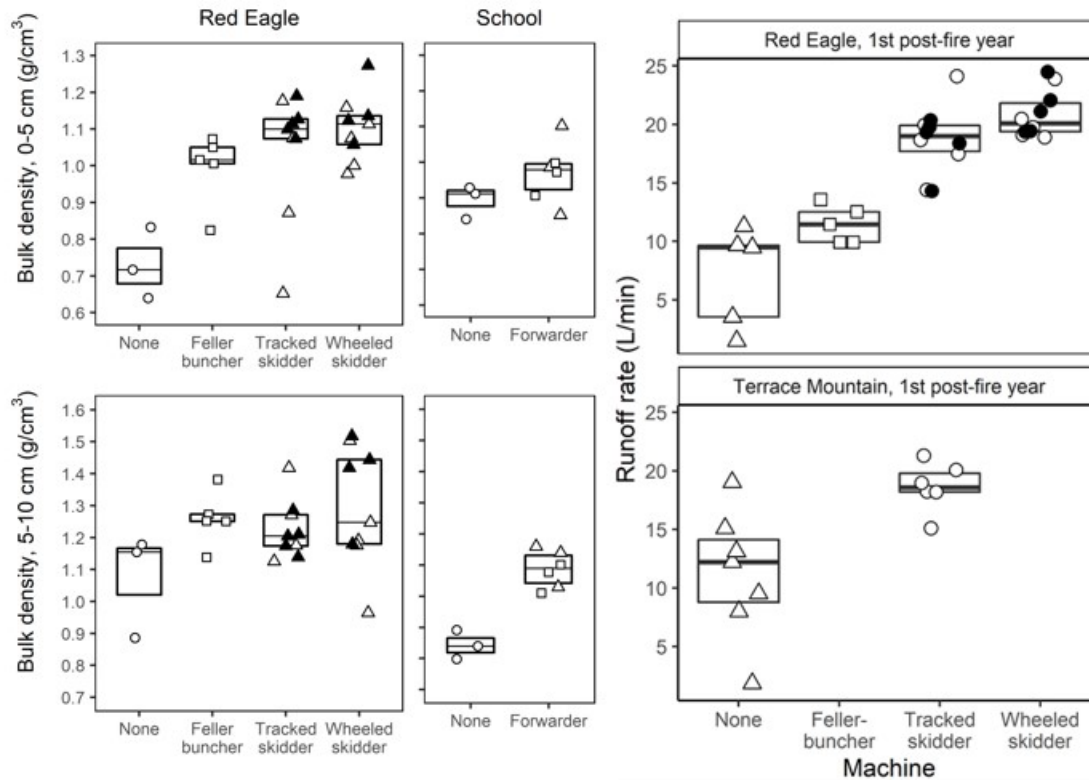
**Figure 5.** Bulk density, a measure of soil compaction (left) and runoff rate during a controlled runoff experiment in areas of high soil burn severity with different types of machine traffic (right). Not all types of machines were tested at each of the study sites (modified from Wagenbrenner et al., 2016). “None” represents high soil burn severity with no salvage logging equipment traffic.

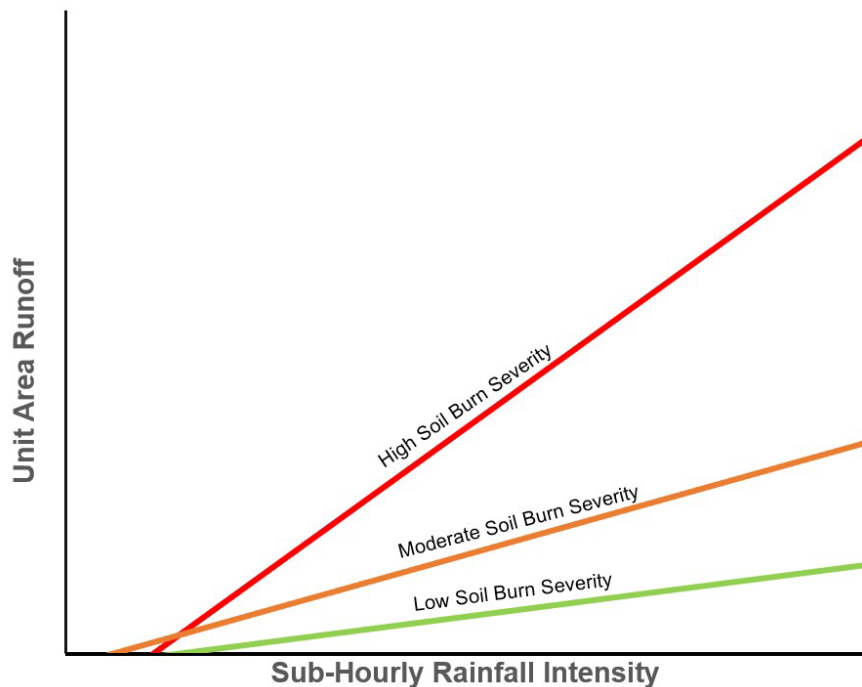
**Figure 11.** Peak stream flow rates in areas of different soil burn severities in the northern part of the California Coast Ranges. Lines reflect the difference in the runoff and rainfall intensity relationship among catchments burned at different soil burn severities for the first winter (2015-2016) following the 2015 Valley Fire at Boggs Mountain Demonstration State Forest.

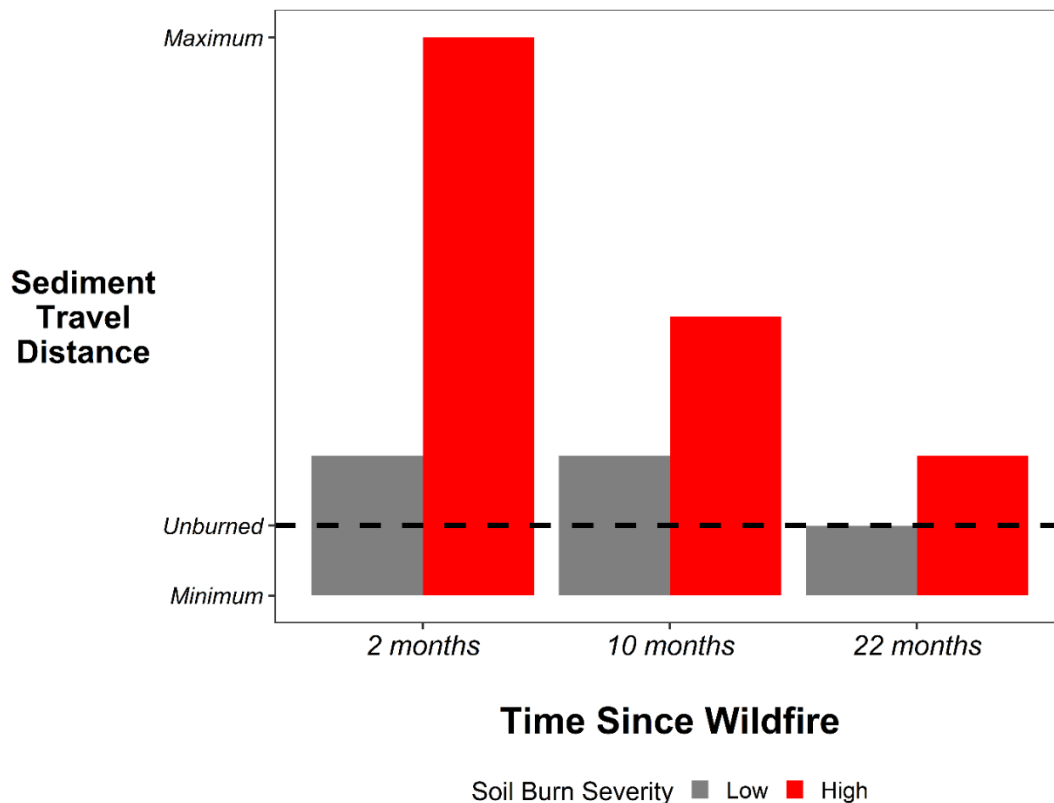
**Figure 13.** Sediment travel distance as a function of soil burn severity and time since wildfire. Figure created using data on the travel distance of applied runoff versus time since burning under different burn severity conditions after the 2015 North Star Fire and 2016 Cayuse Mountain Fire in eastern Washington (Robichaud et al., 2021). For these experiments, sediment-laden runoff was applied to a hillslope of the burn condition, and the distance the runoff traveled before it completely infiltrated was measured. Original data were scaled to the unburned condition to determine the travel distance multiplier. While the data used to make this figure come from burned coniferous forests in eastern Washington, we expect soil burn severity and time since fire to have the same relative effect on sediment travel distances in burned California forests.
